Single event investigation

Devastation in Karen State

Airstrikes on a Monastery and mining facilities, Kyainseikgyi Township

Report by MYANMAR WITNESS FELLOWSHIP PROGRAMME, 19 May 2023

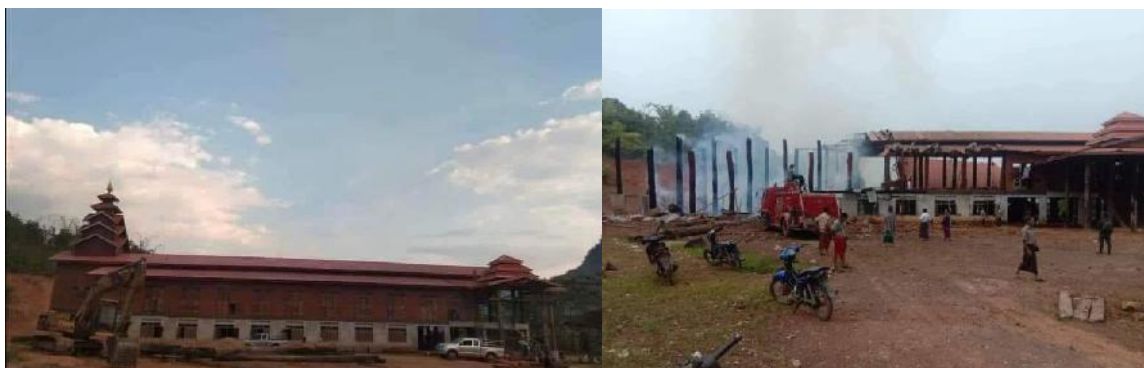
Figure 3: (Left) The Dhamma Rakkhita Monastery before the attack (Source: [Mon News](#)). (Right) Imagery of damage after the airstrike (Source: [Khit Thit Media](#)).

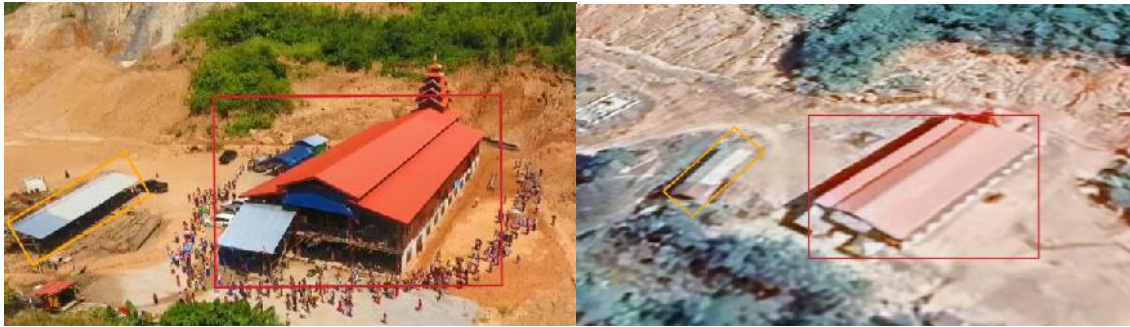
Figure 4: (Left) Still taken from a [video](#) footage of the Dhamma Rakkhita Monastery in October 2019.
(Right) Satellite photo of the Dhamma Rakkhita Monastery [15.389255, 98.381688].

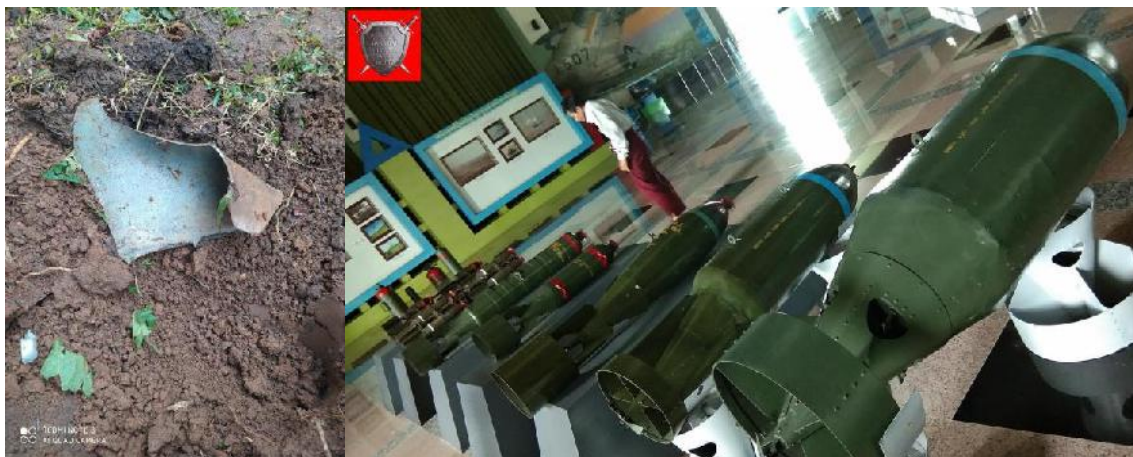
According to the town's inhabitants, as reported by [KIC](#), weapon fragments were found inside the Dhamma Rakkhita Monastery after the attack. The exact type of munition alleged to have been used is not confirmed; however, analysis conducted by Myanmar Witness shows that the fragment is likely from 250-pound or 500-pound bombs. Myanmar Witness has identified reports that these types of bombs have been frequently deployed by the MAF in Karen state.

Figure 6: (Left) Suspected bomb fragments found near the monastery after the airstrike (Source - [KIC](#)). (Right) Bombs commonly used by the SAC in air strikes which are suspected to be the bomb used (Source - [Myanmar Military Online Study](#)).

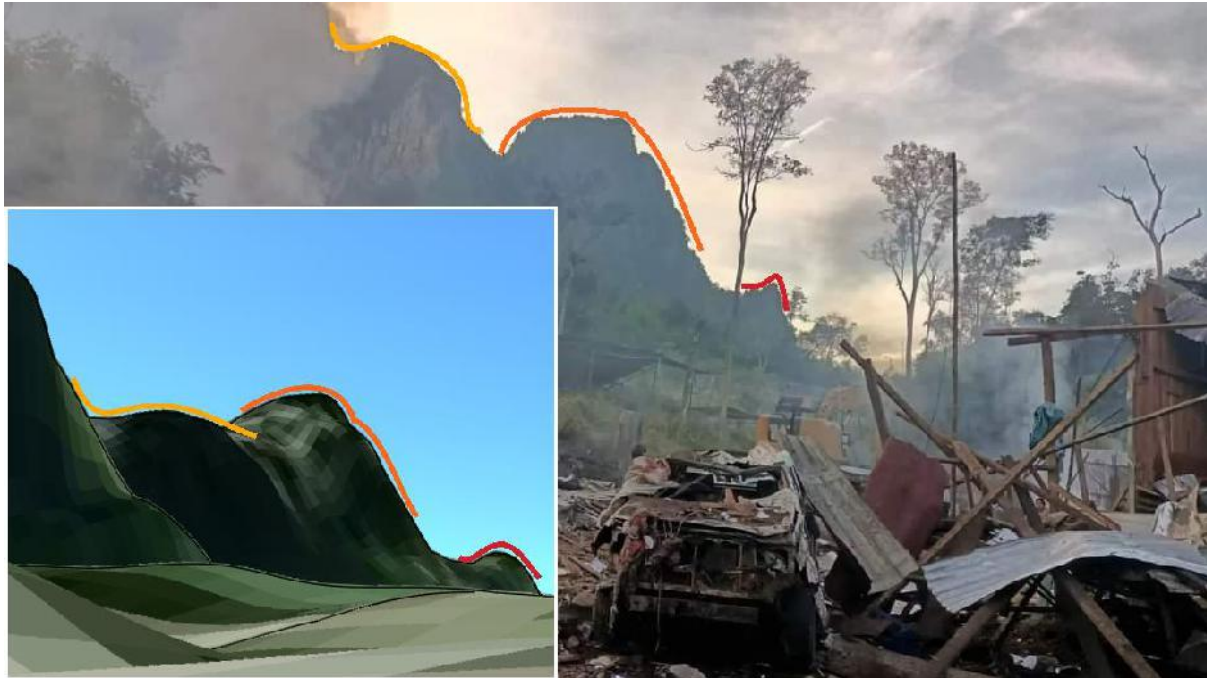
Images released online by news source [Khit Thit Media](#), allegedly following the airstrike on 16 November 2022, show extensive damage to the mine site. However, Myanmar Witness has been unable to geolocate or chronolocate these images with confidence.

Figure 7: The scene after the airstrike against block 6 of the Thabyu Mine (သံဂျိရဲငံး) reportedly on the morning of 16 November 2022. Location of the damages is verified with [Peakvisor](#) [15.619399, 98.406799] (Source: [Khit Thit Media](#)).

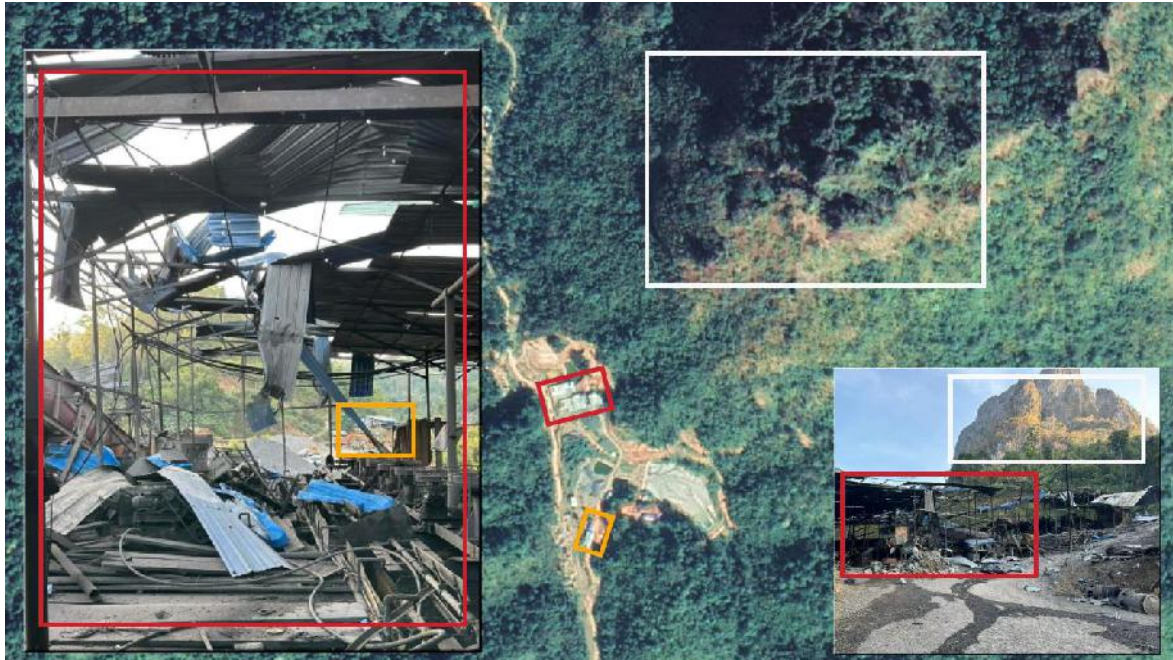
The damaged buildings were also checked and verified against [Google Earth](#) satellite imagery.

Figure 9: Confirmation of the geolocation of the damages to block 5 of Thabyu Mine [15.606206, 98.410007].
 (Source redacted due to privacy/safety concerns)
