**Documenting Rubble: How Russia Destroyed More Than 300 Buildings
in Ukraine's Makariv**

Guy Agam Fufus and Benjamin den Braber. With contributions from Sofia Santos.

7 June 2022

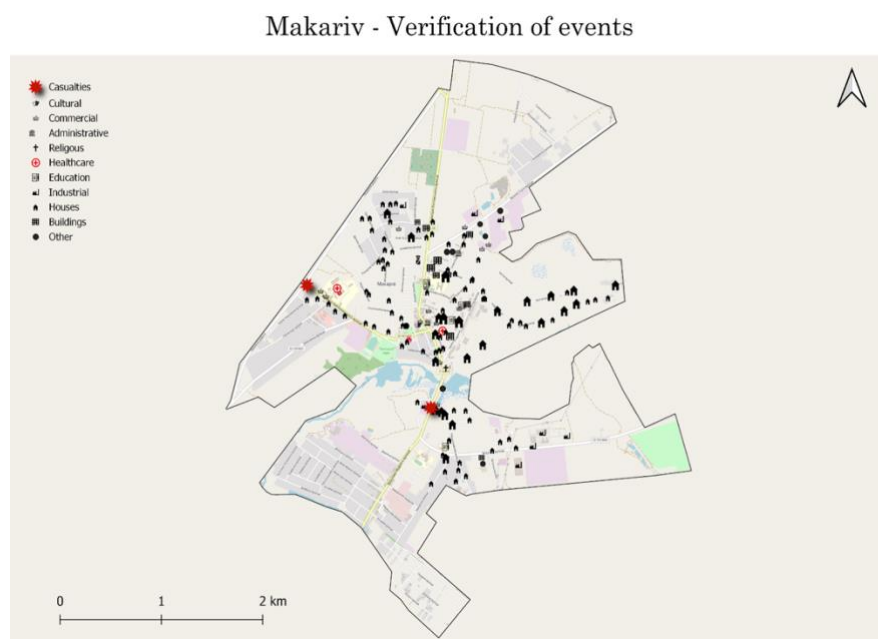
Figure 1: A map showing all verified incidents of civilian casualty and infrastructure damage in Makariv.

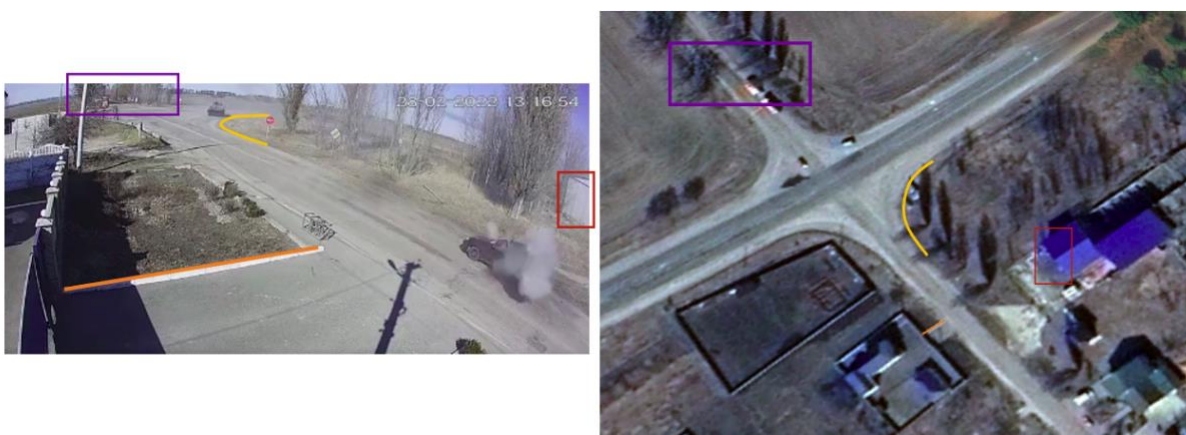
Figure 2: Geolocation of CCTV footage showing a civilian vehicle being targeted in Makariv.

The car is seen driving West towards an intersection as tanks arrive from the North. The Russian BMP-2 amphibious infantry fighting vehicle was shooting towards the car three times.

Following a geolocation suggested by a Twitter [user](#), EoR investigators were able to confirm the location of the video. The attacked car was driving West on Bohdana Khmelnytskoho street in Makariv.

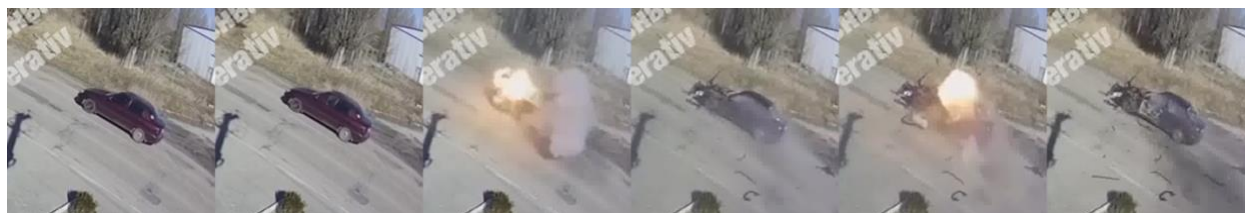
The first shot was fired while the Military vehicles were driving. Apparently, the first shell partially hit the car but did not cause widescale destruction. After the first hit, the car stayed static.

The next shot took place five seconds later. At that time, the first tank in the convoy already made it to the intersection. As the tank was 60 meters from the vehicle, he opened fire once again.

The shells directly hit the front part of the car. Footage from the scene shows a large explosion, followed by smoke billowing from the vehicle. Six seconds after the second shot, the BMP-2 fired a third time, causing another explosion and the car is seen completely destroyed.

Figure 3: Sequence of events showing the civilian vehicle hit, causing multiple casualties.

In the background, the military convoy continues its journey and heads West at the intersection, followed by the BMP-2 that opened fire at the civilian vehicle.

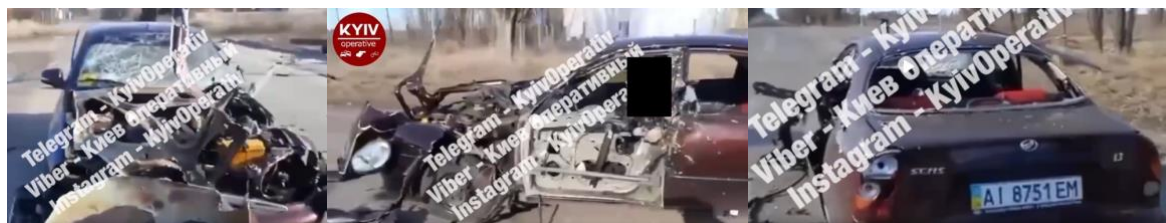
Figure 4: Images of the destroyed civilian vehicle.

On 10 March, Kyiv Oblast police [announced](#) the death of a couple in their seventies as a result of this event.

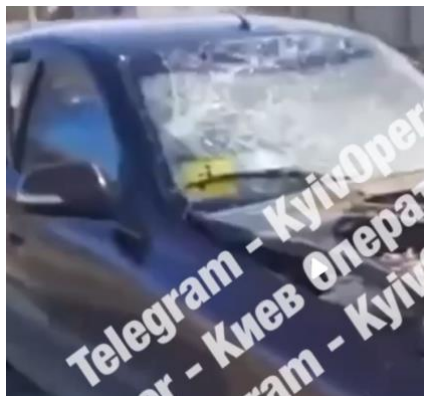
Further footage also shows a clear indication of a handicap sticker on the front of the car.

Figure 5: An Image of the destroyed vehicle, and a clear indication of a disabled user sign on the front of the car.

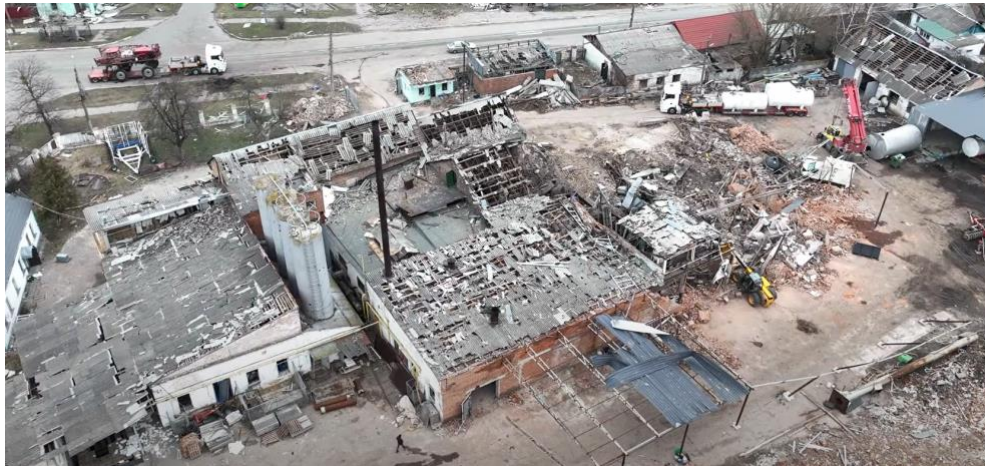
Drone [footage](#) posted on 5 April showed damage to multiple buildings in the facility, some of them were severely damaged.

Residential and commercial buildings across the street were damaged as well, though it is not clear if it was due to the same attack.

Figure 6: A screenshot of drone footage showing the damage to the bread factory.

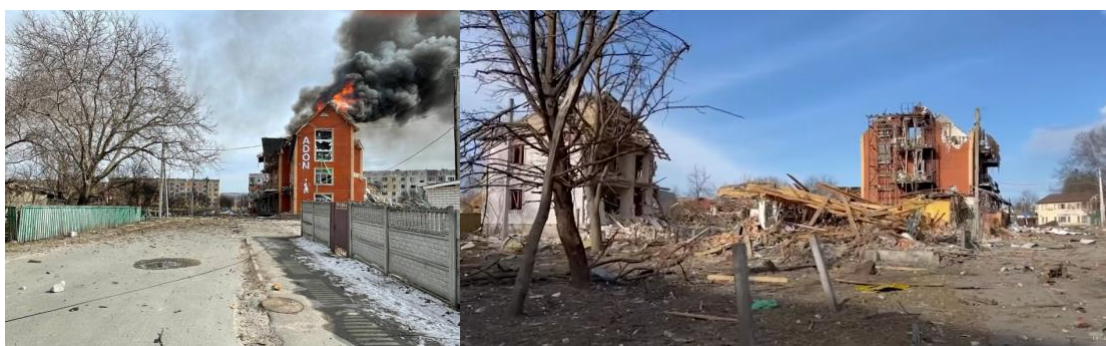
Footage showed fire rising from the roof of the clinic and significant damage to the building’s front, suggesting that it suffered a direct hit.

A YouTube [video](#) that was uploaded on 1 April shows the aftermath of the attack. The clinic was severely damaged, while nearby buildings were completely destroyed.

Figure 8: Footage from the aftermath of the attack on ‘Adonis,’ a private clinic in Makariv.

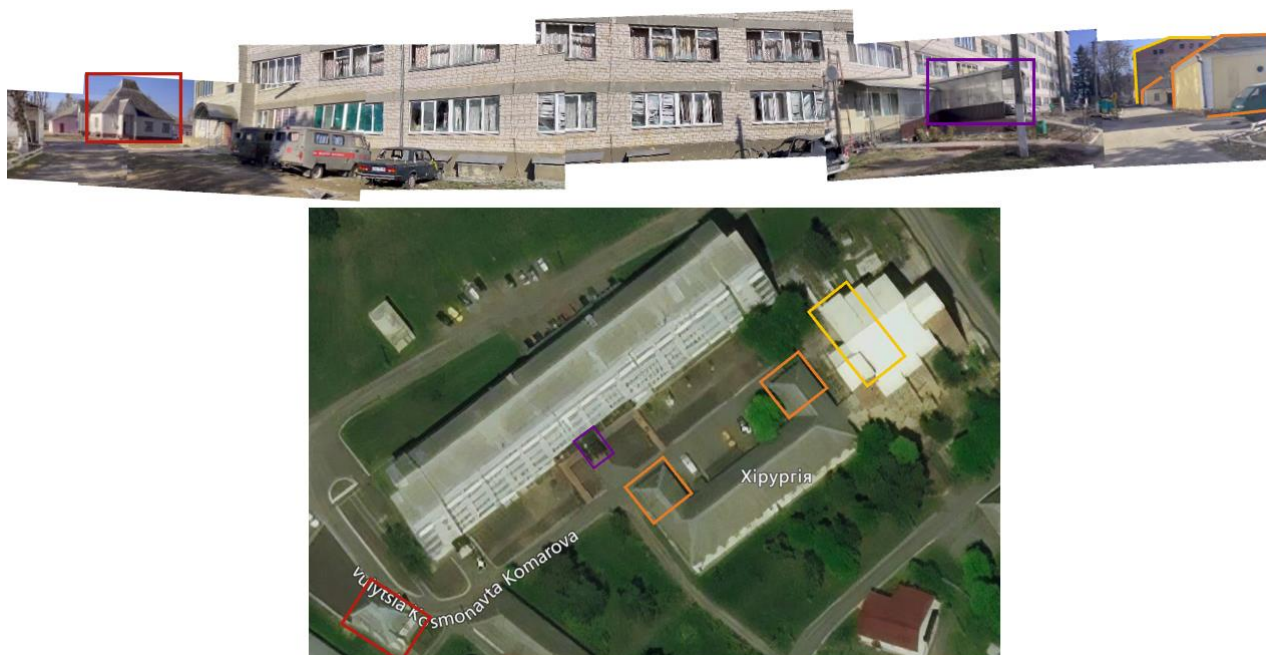
Figure 9: Geolocation of footage showing damage to Makariv's Hospital.

Many windows of the main hospital building appear broken, and shrapnel damage to the building is visible as well.

Shrapnel damage is seen on one of the walls of the surgical buildings across the road.

An additional building has a crater in its roof, as well as shrapnel damage on the external wall. Seven vehicles have also appeared to sustain damage. At least three of them were ambulances.

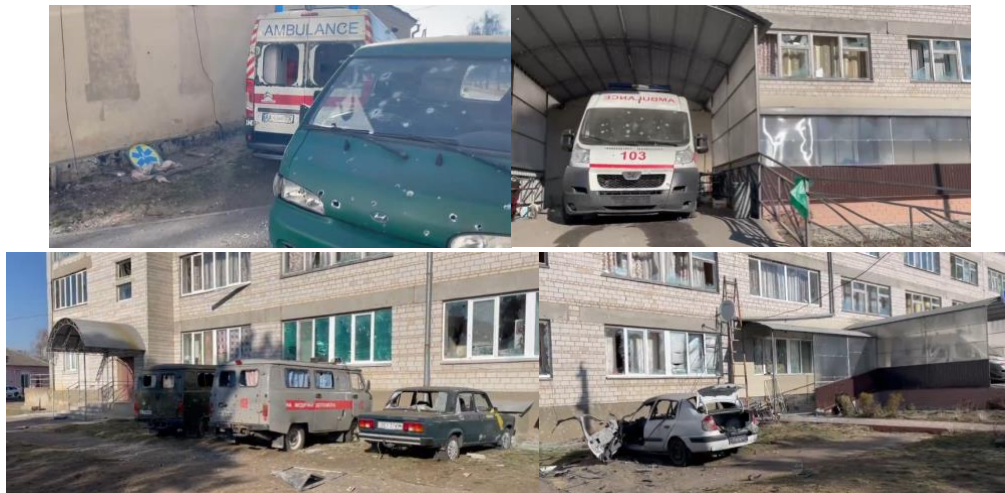
Figure 10: Footage showing the aftermath of the destroyed hospital in Makariv.

Footage from the scene also shows a crater with a tail fin. EoR investigators believe the crater was caused by OF-843B, a high explosive 120mm mortar round used by the Russian army.

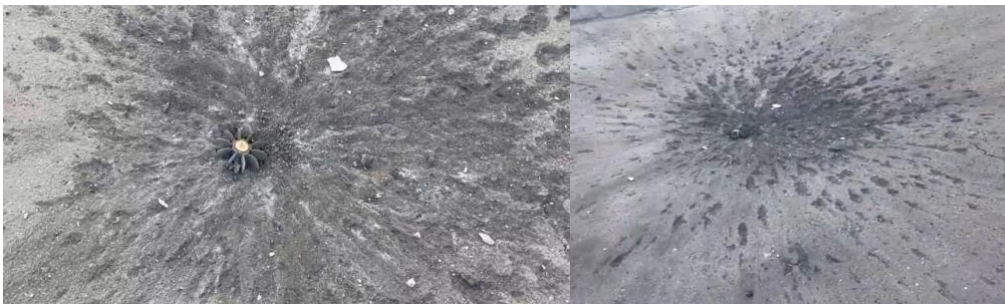
Figure 11: Footage showing the crater caused by the explosion.

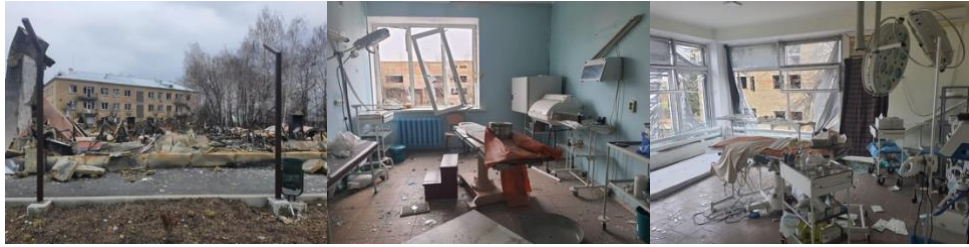
Figure 12: Footage showing the destruction of an outpatient clinic and eastern rooms in Makariv's hospital.

Images [posted](#) by Ukraine's health minister on 5 April showed that an outpatient clinic was completely destroyed at the Hospital premises.

Additional images showed damage to treatment rooms in the eastern section of the hospital.

On 18 April, Makariv Town Council [announced](#) on their Facebook page that several sections of the hospital were reopened.

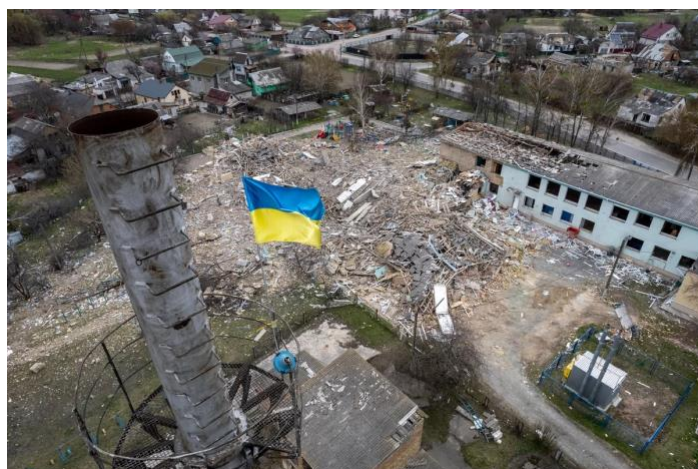
An image [posted](#) on 19 April shows damage to “Barvinok” kindergarten on Vatutina street.

Figure 14: Footage showing the destruction of Barvinok kindergarten.

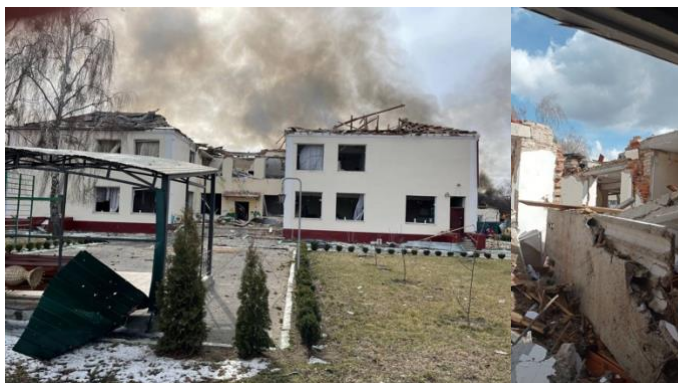
Following a suggested geolocation [posted](#) on Twitter, EoR investigators were able to confirm that it shows a destroyed kindergarten, “ЗДО Теремок”, in Makariv.

Figure 15: Footage showing the destruction of “ЗДО Теремок”, kindergarten in Makariv.

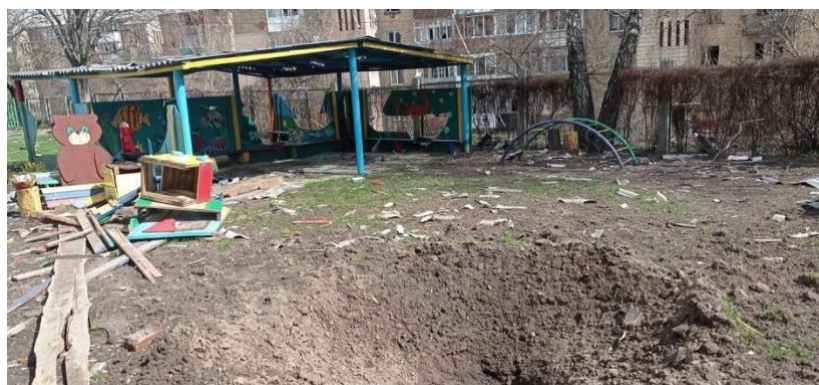
Figure 16: Footage showing a crater in “ЗДО Теремок”, kindergarten in Makariv.

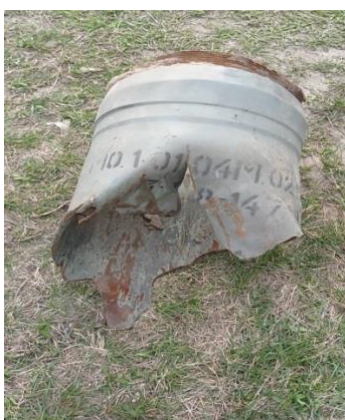
Figure 17: Footage showing the remains of a 300mm 9M55K rocket.

One image seemingly revealed the remains of a 300mm 9M55K rocket launched from a Smerch MLRS. Two more education facilities were damaged. The extent and time of attack were not clear.

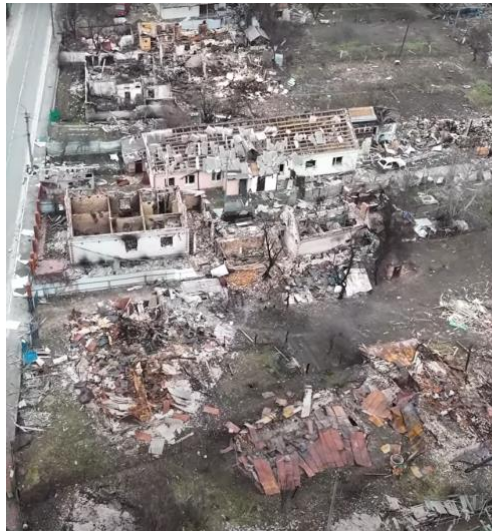
Based on publicly available drone footage from Makariv, EoR investigators were able to count 328 houses and 282 apartments that were damaged following Russian shelling.

Some of the properties were completely destroyed, and others were partially damaged.

Figure 19: A Screenshot of drone footage showing the destruction of residential buildings.

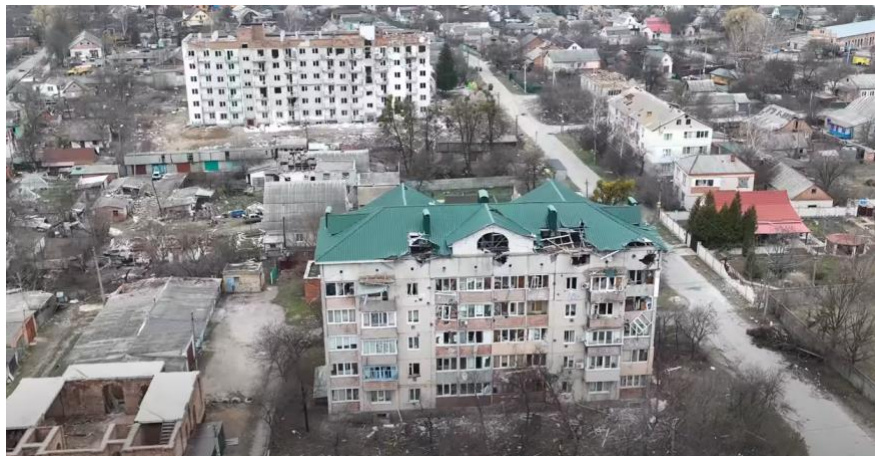
For apartment buildings, EoR investigators included all the apartments in a building with visible destruction, as the damage to each apartment cannot be determined.

Figure 20: A screenshot of drone footage showing the destruction of apartment buildings.

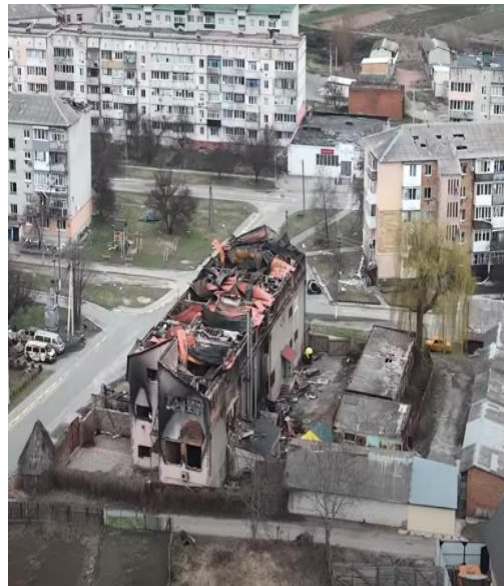
Similarly to residential infrastructure, EoR investigators were able to count 32 commercial properties with visible damage from open-source footage.

A hotel, a market and pharmacies were among the damaged properties. In addition, EoR investigators noted damage to at least 21 industrial properties.

Figure 23: A screenshot of drone footage [showing](#) widescale damage to commercial properties in Makariv.

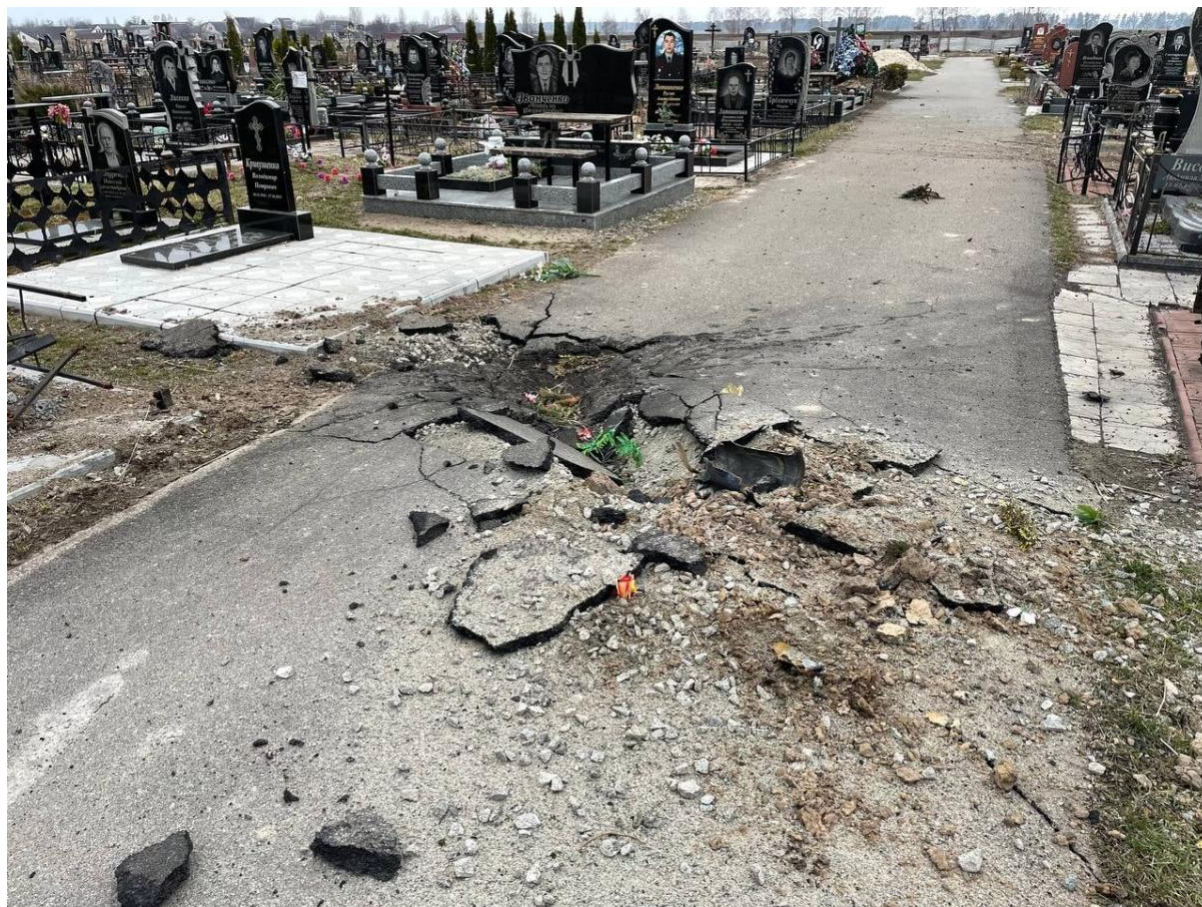
A photo [posted](#) on Makariv's town council's Facebook page showed damage to the town's cemetery.

Figure 24: Footage showing damage to Makariv's cemetery.
